St Agnes Conservation Area Appraisal

1.0 Introduction

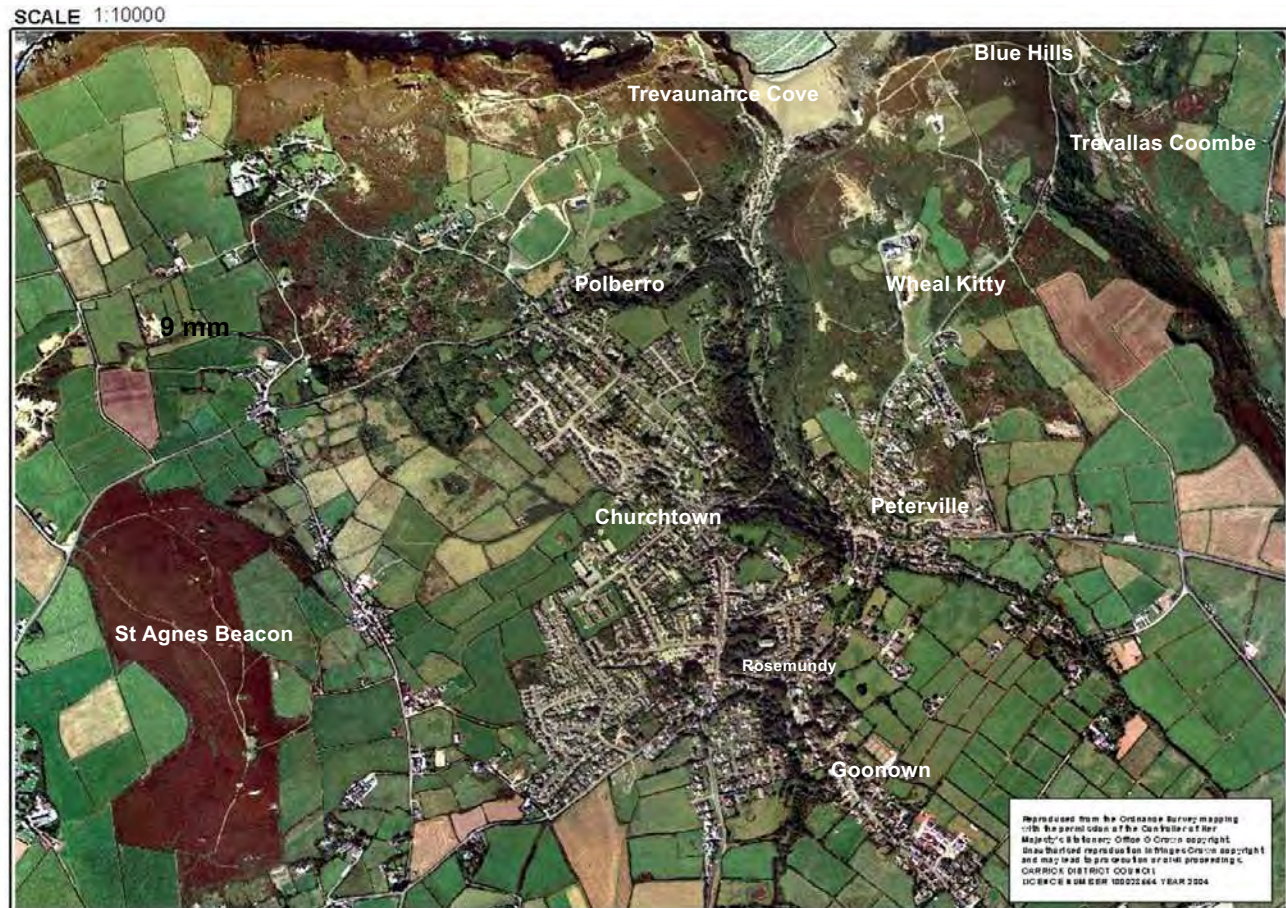
Fig 2. Aerial photo of St Agnes

5.3 St Agnes Churchtown is built on a terrace of land below St Agnes Beacon, overlooking the narrow and deeply incised Trevaunance Coombe valley running down to the sea at Trevaunance Cove. Vicarage Road, runs along the level

terrace above the valley. The village radiates out from Churchtown and along Vicarage Road and Rosemundy towards Goonown, encompassing Peterville at the head of Trevaunance Coombe and west along Trevaunance Road. As a result the

settlement appears to cling to the steep slopes of the valley sides, with the higher moor land forming a backdrop beyond. See aerial photograph.

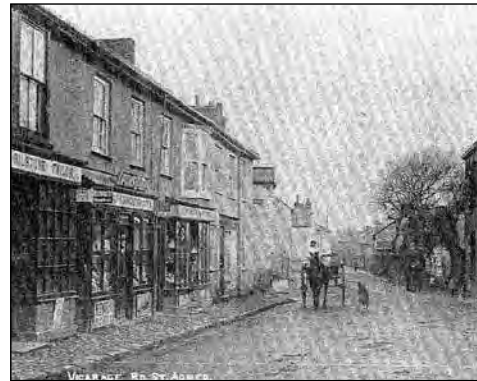
Fig 19. Vicarage Road, St Agnes, around 1920, with the unmaded road and cobbled pavement in front of the shops. It is interesting to note that shop use for some of these properties is still prevalent today.

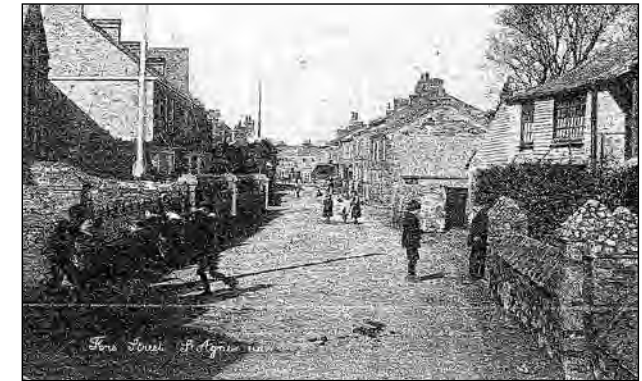
Fig 20. Vicarage Road, 1905. The flag pole erected in the foreground of the Miners and Mechanics Institute erected in 1900 has not survived. The lean-to on the building in the middle of the photograph has also been removed.

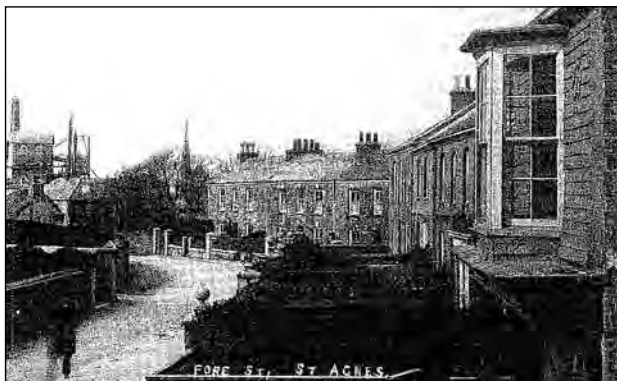
Fig 21. Fore Street 1906 looking towards Churchtown with West Kitty engine house on the skyline. It is good to note the survival of much of the front boundary wall treatments and architectural details today.

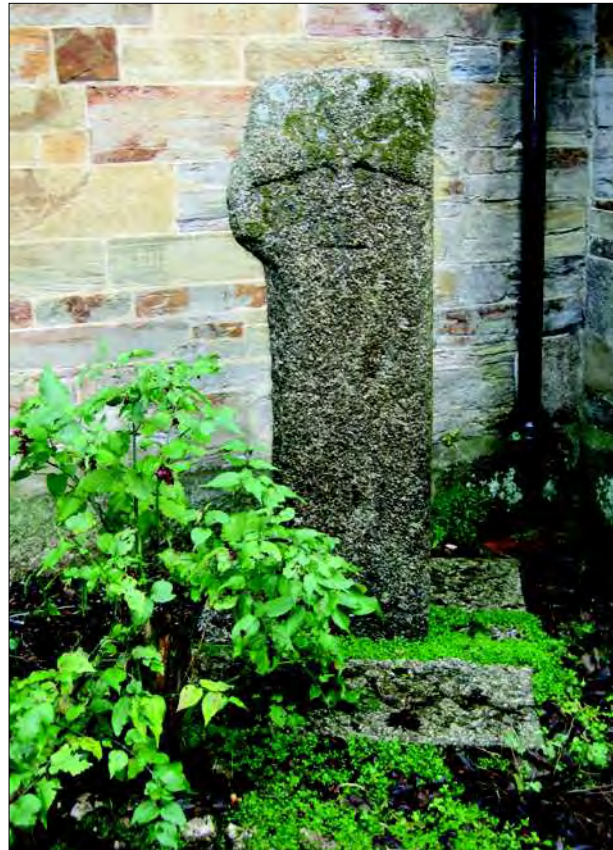
Fig 25. Photograph of Cross at west end of St Agnes Church.

- **Medieval Wayside Cross in St Agnes' Churchyard** - situated to the south west of the church the wayside cross, listed grade II, survives as an upright granite shaft with a round, 'wheel' head mounted on a modern granite base measuring some 1.58m in height. The wayside cross has survived well and is a good example of a wheel headed cross. It is thought to have acted as a waymarker on a church path.

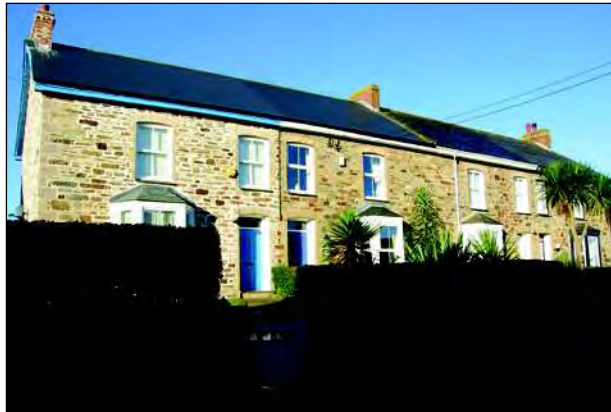
Fig 28. Well maintained Victorian terrace, Vicarage Road.

9.4 The area is also distinct in its 'organic' and 'planned' parts of the study area that contribute to the overall character. There is for example, a contrast between Churchtown (especially the rear lanes with their intimate alleyways and strangely shaped and reshaped buildings) and the formality of the rows only yards away in Vicarage Road, creating a rich and interesting built environment.

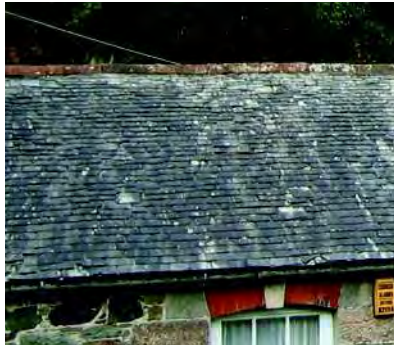
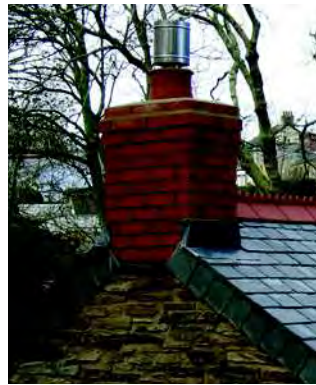
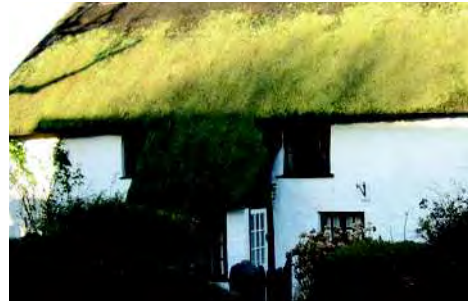
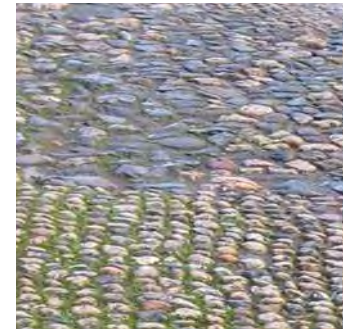
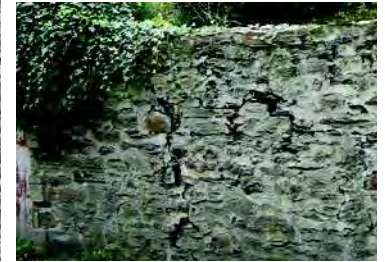
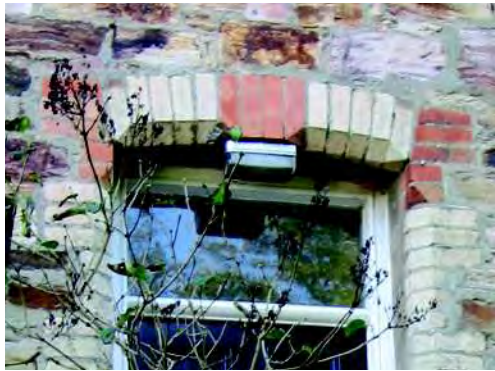
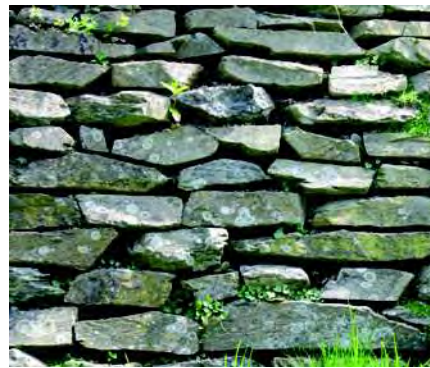
Fig 35. Form

The typical Cornish house is low pitched, slate roofed and built of blocks of grey-brown granite or slate. They appear as simple, straightforward buildings, of good proportions, in harmony with their immediate context and local environment. As Nicholas Pevsner noted in the introduction to his Buildings in Cornwall, “the attraction lies in the whole, not in parts.”

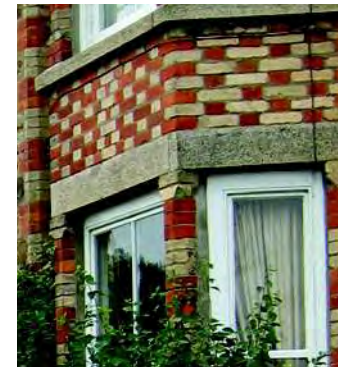
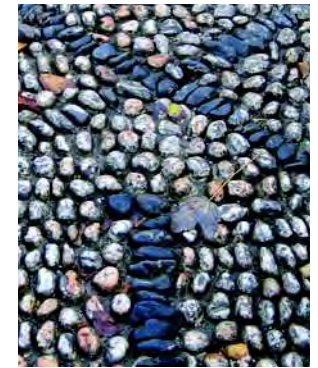
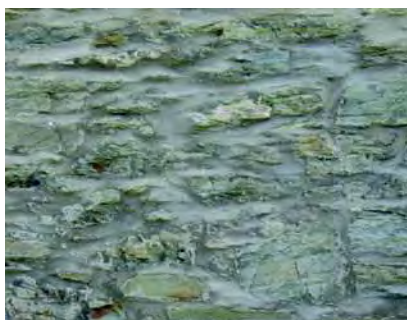
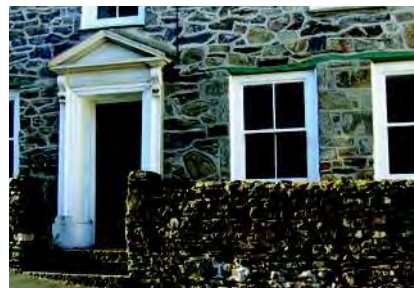
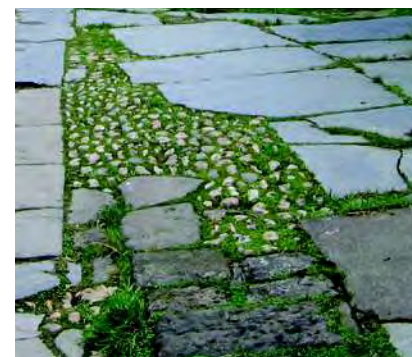
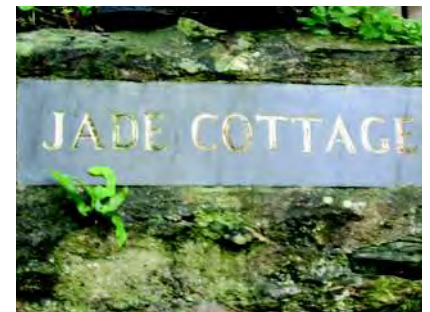
materials
& local
details

12.1 St Agnes is a stone built settlement. For the most part, the stone used is the local country stone, or 'killas', varying in colour from grey-green to a buff or rich reddy-brown, relatively friable and laid as rubble or roughly coursed. Many of the older cottages and houses have been rendered, painted or whitewashed (probably quite a prevalent protection measure historically).

12.5 Ashlar stonework is rare - the Porthvean Hotel and Churchtown Stores are almost the only 18th century examples in St Agnes, although many of the 18th and 19th century buildings in Churchtown are of better quality dressed and coursed stonework than the usual local type, and many of the later 19th century villas show some good quality cut stonework (more often granite than the local sandstones). Good quality stonework of an exceptional type can be found in the traceried windows of the Board School by J D Sedding.

12.6 Fine timber joinery is much in evidence on the many good shop fronts, and is also a feature of many of the 19th century villas (bay windows, door and fenestration surrounds, ornamental barge-boards). Although replacement windows in a variety of styles and materials are common and in some cases particularly intrusive and inimical to historic character, there are still many good surviving examples of original fenestration, particularly sash windows, still surviving – a feature of the settlement.

12.11 There has been extensive replacement of both roofing types in the late 20th century with artificial roofing materials not appropriate to the historic character and quality of the area, although a great deal of original slating (with traditional techniques of random widths and diminishing courses much in evidence) and good quality recent replacement survives.
